Unstable Wall Secured, Given Face Lift

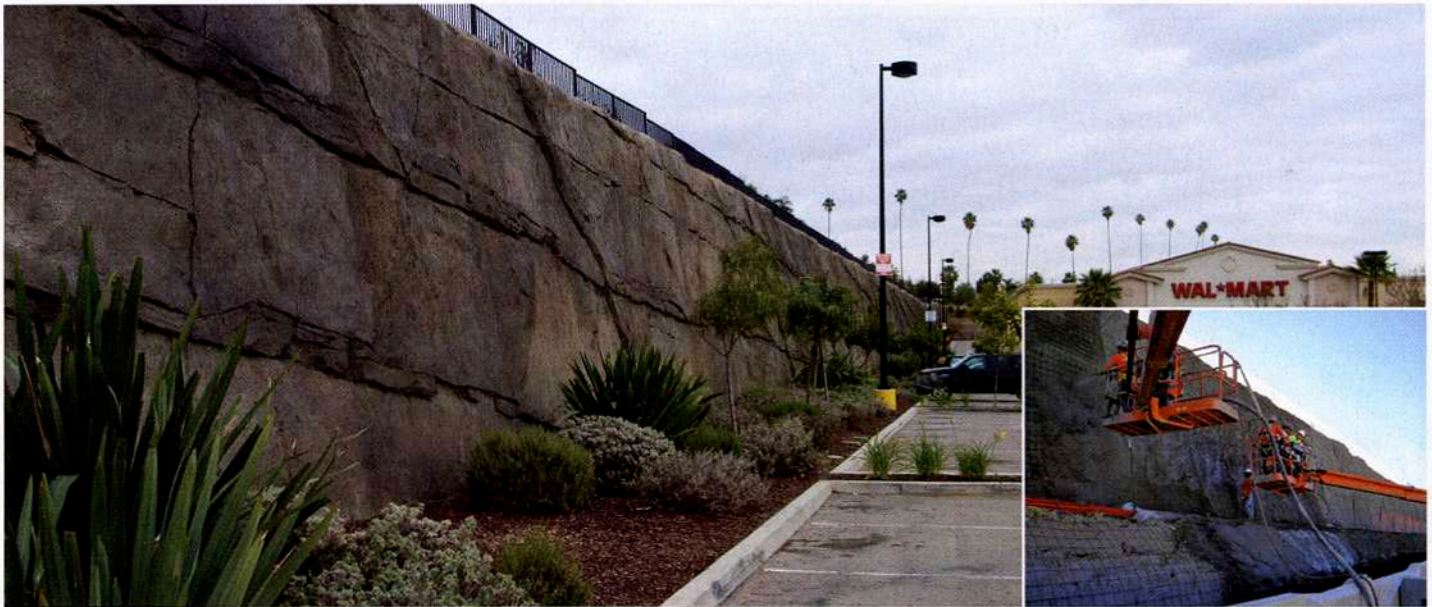
Above: Once the wall was secured, large, steel plates were visible and stuck out along the length and height of the wall. The question was how to make the wall more aesthetically pleasing. An affordable and attractive design solution was to sculpt layers of architectural shotcrete to give a fractured, sandstone look to the wall, then applying a stain.

There were three key steps. First they installed an eight-inch layer of structural shotcrete to the wall face section by section. A second architectural shotcrete layer one to three inches thick was then applied. While the shotcrete was still wet, artisans free-hand sculpted a fractured, sandstone look. The final step was an application of stain, which brought the colorless surface to life. The makeover took six experienced team members 14 days, typically half the time it would have taken with other types of wall finishes.

Homeowners and Wal-Mart were pleased the wall was secure, but the wall now had a raw, unfinished look. Large, ugly steel plates were visible everywhere, sticking out sometimes 10-12 inches throughout the entire length and height of the wall.

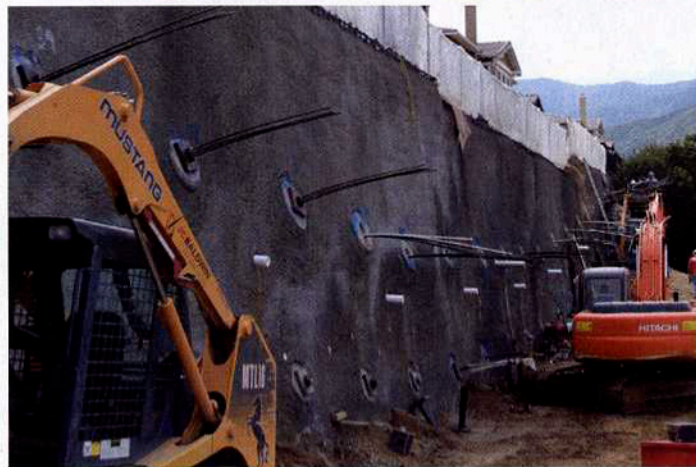
Left: To secure the creeping wall, eight-inch diameter holes were bored into the soil behind the wall, then 80-100-foot-long cables lowered into the holes and grouted. Flat-metal rings were installed over the holes. By pulling on the plates with a large machine the cables forced the retaining wall back into place. Large steel nuts were then attached over each plate to secure the wall's position.

Baldwin Construction, a drilling contracting company from Carlsbad, Calif. was hired to anchor and stabilize the wall. A tieback system was employed. Multitude deep holes eight inches in diameter were bored into the soil behind the wall, then 80-100-foot-long cables lowered into the holes and grouted. Large, flat-metal rings were installed over the holes. A large machine pulled on the plates, which then slid the cables, forcing the retaining wall back into its proper position. To permanently hold the wall, large steel nuts were attached over each plate.
